DEPARTMENT OF TRANSPORTATION

Quality Assurance and Source Inspection

Contract #: 04-0120F4Cty: SF/ALA Rte: 80 PM: 13.2/13.9File #: 69.28**WELDING INSPECTION REPORT****Resident Engineer:**Siegenthaler, Peter**Address:** 333 Burma Road**City:** Oakland, CA 94607**Report No:** WIR-019695**Date Inspected:** 01-Jan-2011**Project Name:** SAS Superstructure**OSM Arrival Time:** 700**Prime Contractor:** American Bridge/Fluor Enterprises, a JV**OSM Departure Time:** 1900**Contractor:** Zhenhua Port Machinery Company, Ltd (ZPMC), Changxing Island **Location:** Shanghai, China**CWI Name:** Xu Le Feng**CWI Present:** Yes No**Inspected CWI report:** Yes No N/A**Rod Oven in Use:** Yes No N/A**Electrode to specification:** Yes No N/A**Weld Procedures Followed:** Yes No N/A**Qualified Welders:** Yes No N/A**Verified Joint Fit-up:** Yes No N/A**Approved Drawings:** Yes No N/A**Approved WPS:** Yes No N/A**Delayed / Cancelled:** Yes No N/A**Bridge No:** 34-0006**Component:** TOWER & OBG Components**Summary of Items Observed:**

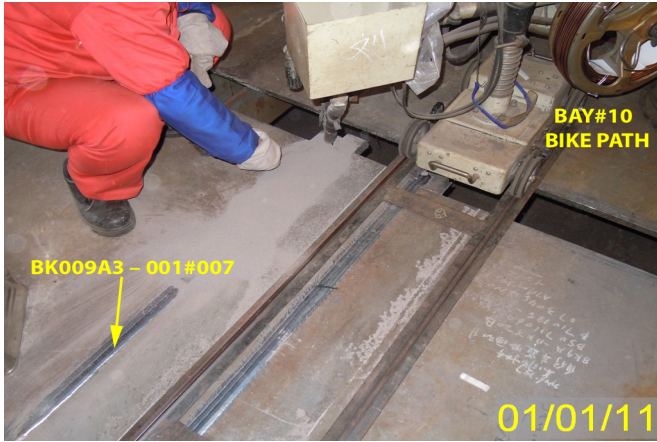
Weld joint # 007 located on Bike path stringer plate BK009A3 – 001. Welder is identified as 040460. ZPMC Quality Control (QC) Inspector is identified as Yu Zhi Lai. The welding variables recorded by QC appeared to comply with the WPS – B – T – 2221 – B – L2c – S – 2. (See attached photo)

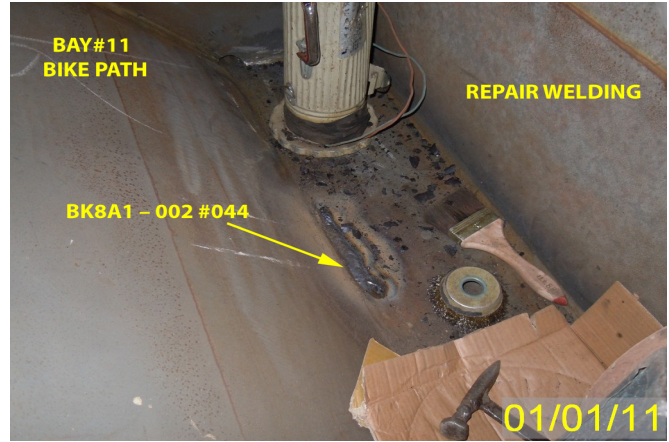
Repair welding of weld joint # 44 located on Bike Path BK8A1 – 002 as per the weld repair report # B-WR19147. Welder is identified as 054460. ZPMC Quality Control (QC) Inspector is identified as Yu Dong Ping. The welding variables recorded by QC appeared to comply with the WPS – 345 – SMAW – 1G (1F) – Repair. (See attached photo)
